**Libby Asbestos Superfund Site
The Former Screening Plant and Surrounding Properties
Operable Unit 2
Lincoln County, Montana**

Draft Remedial Action Report

February 4, 2011

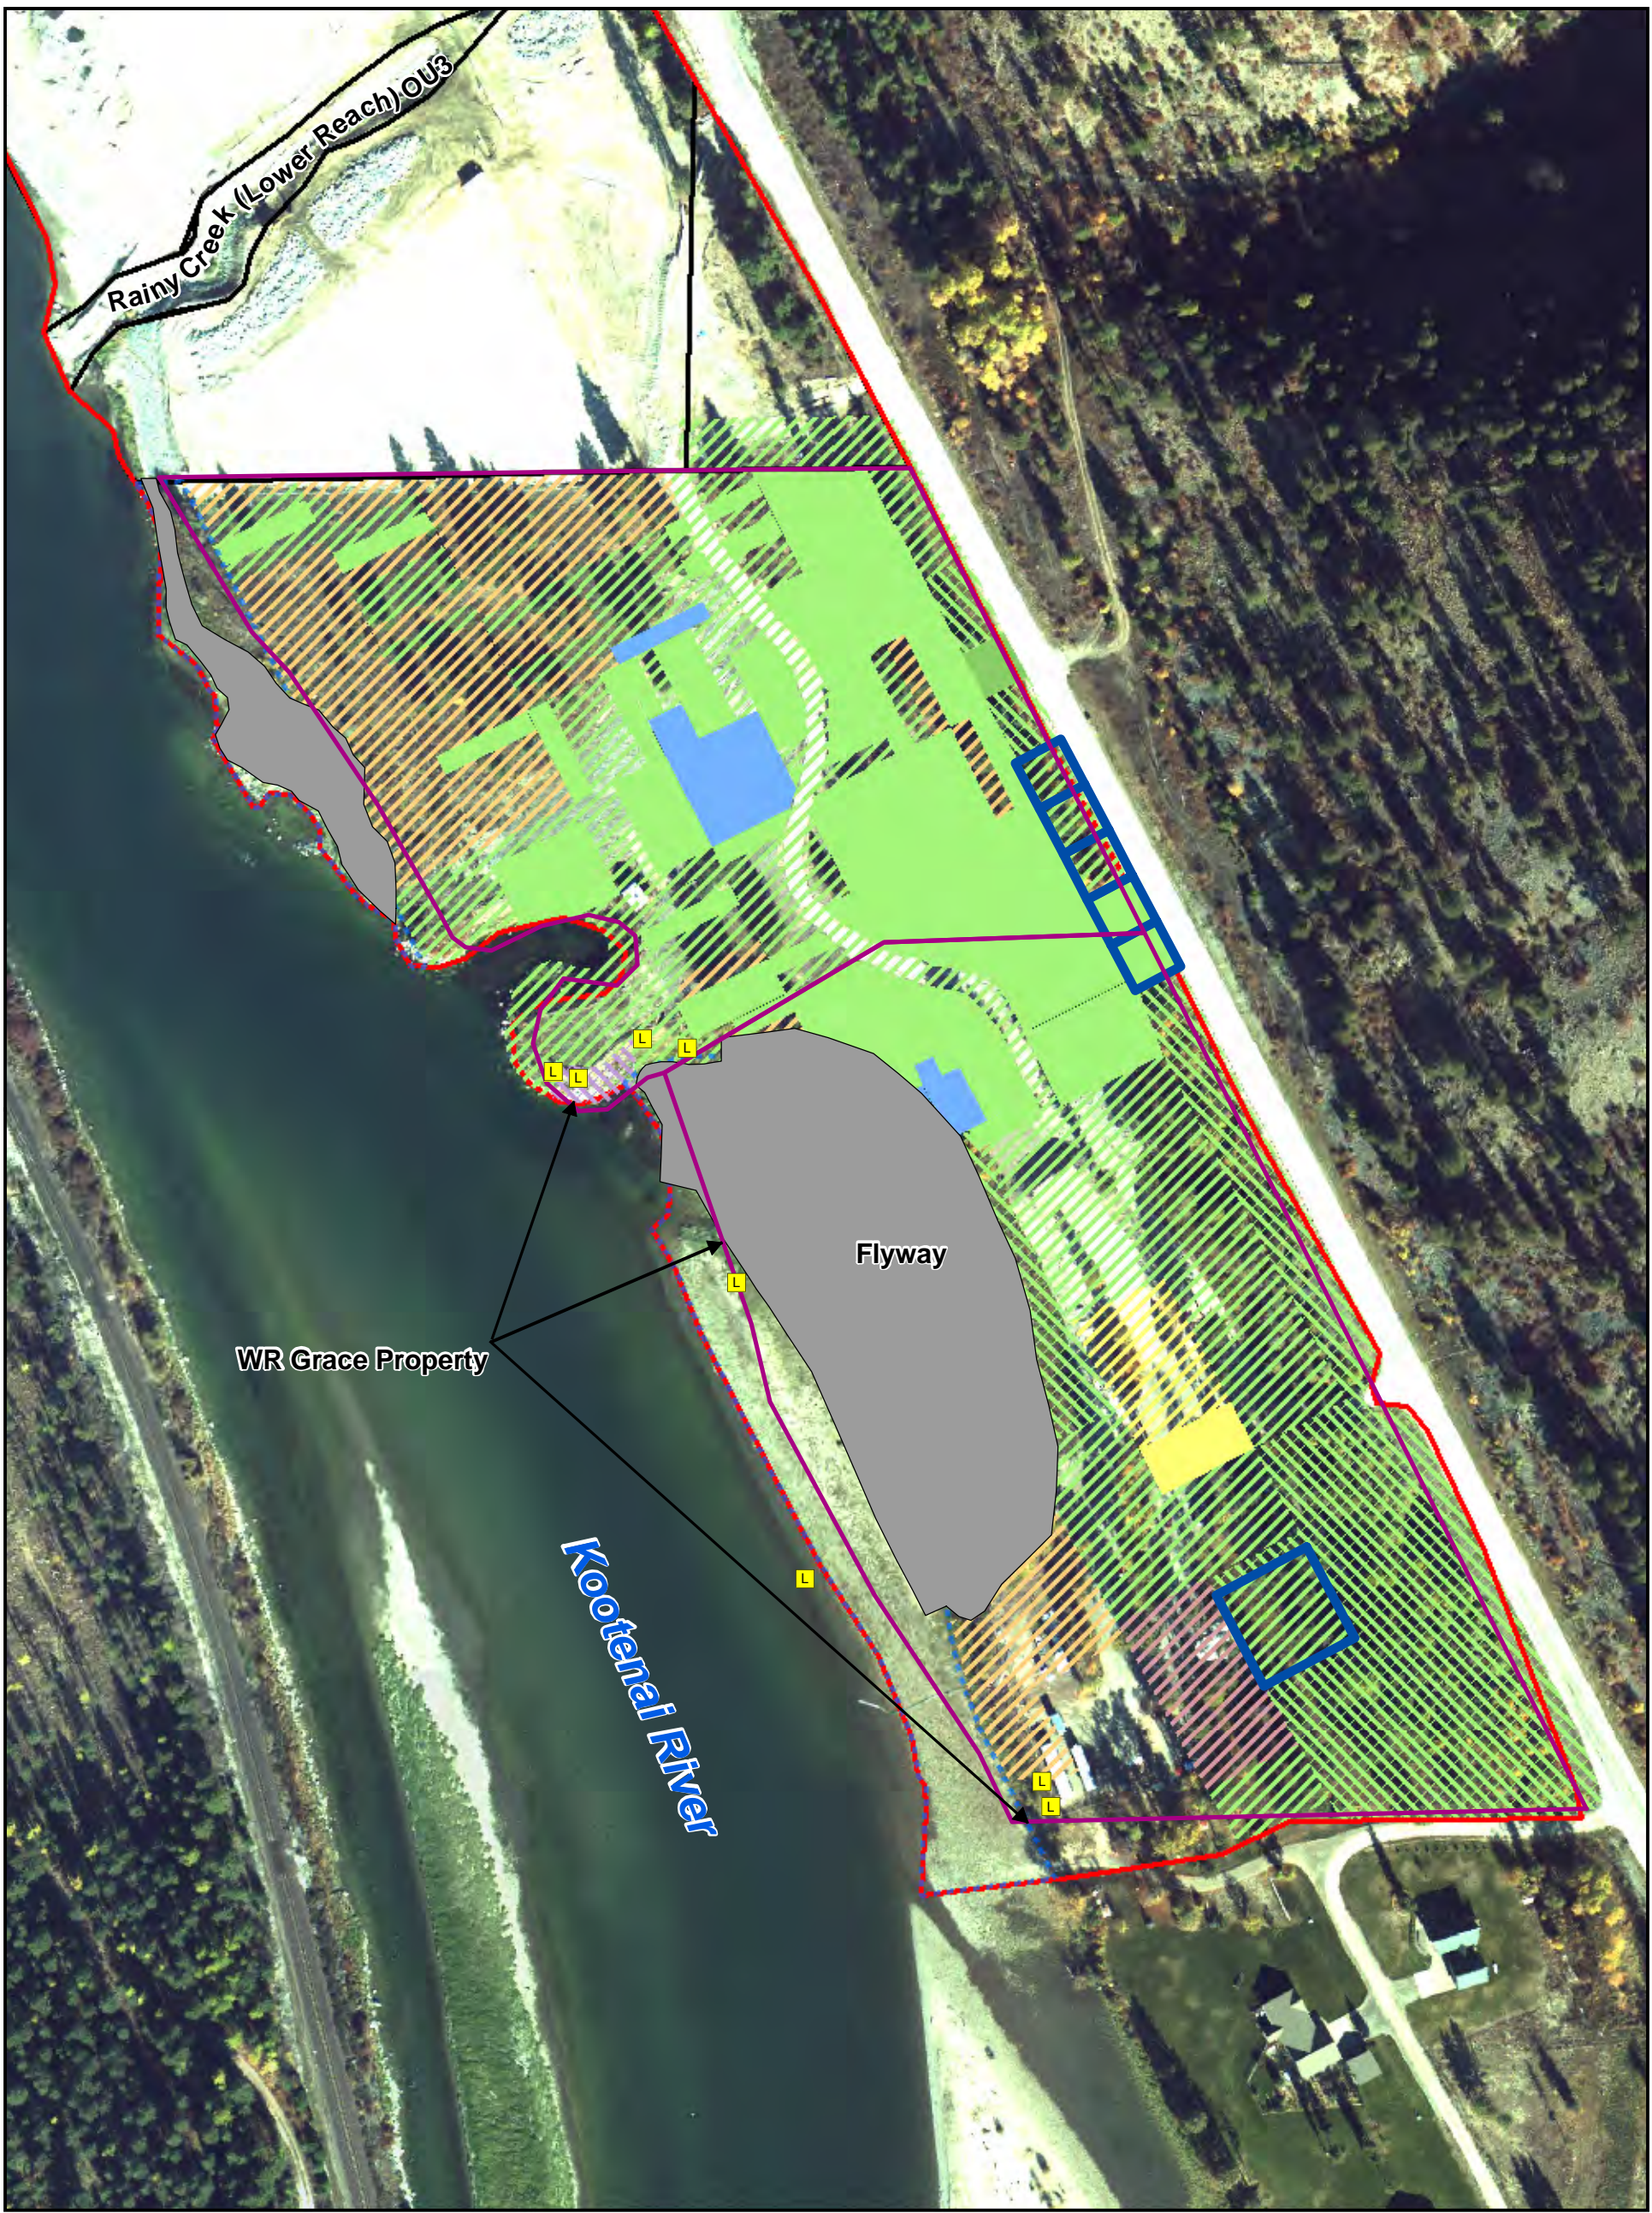
Figure 2-3
Location and Depth of Residual Contamination
at OU2 - WR Grace Property Based on
Investigation Activities and Removal-related
Confirmation Soil Sampling
Libby Asbestos Superfund Site
Lincoln County, Montana

- The Final RI Report (EPA 2009b) indicates that residual contamination may be found at shallow depths, specifically within the vicinity of utility poles, guy wires, the edges of roadways, property boundary markers, state highway boundary markers, and National Forest property bounds. EPA directed CDM to produce a new figure for this report based on RI Figure 2-3 that shows areas where LA contamination may be found at shallow depths.

- Figure 2-3 of the Final RI Report (EPA 2009b) indicates that residual LA contamination may be found at depths greater than 4 feet bgs over a large portion of the former Screening Plant (Subarea 1). Some of this area was excavated and restored with clean fill to a depth greater than 5 feet. Note that in the memorandum the clean fill depth was incorrectly reported as 4 feet. EPA directed CDM to produce a new figure based on RI Figure 2-3 that identifies areas where residual LA contamination may be found at depths greater than 5 feet below existing grade.

- Figure 2-3 of the Final RI Report (EPA 2009b) identifies four areas within the former Screening Plant (Subarea 1) where residual contamination may be found at less than 1 foot bgs. To confirm that a minimum of 12 inches of clean fill exists over any potential residual LA contamination, EPA and MDEQ agreed that each of these areas should be sampled as soon as possible.

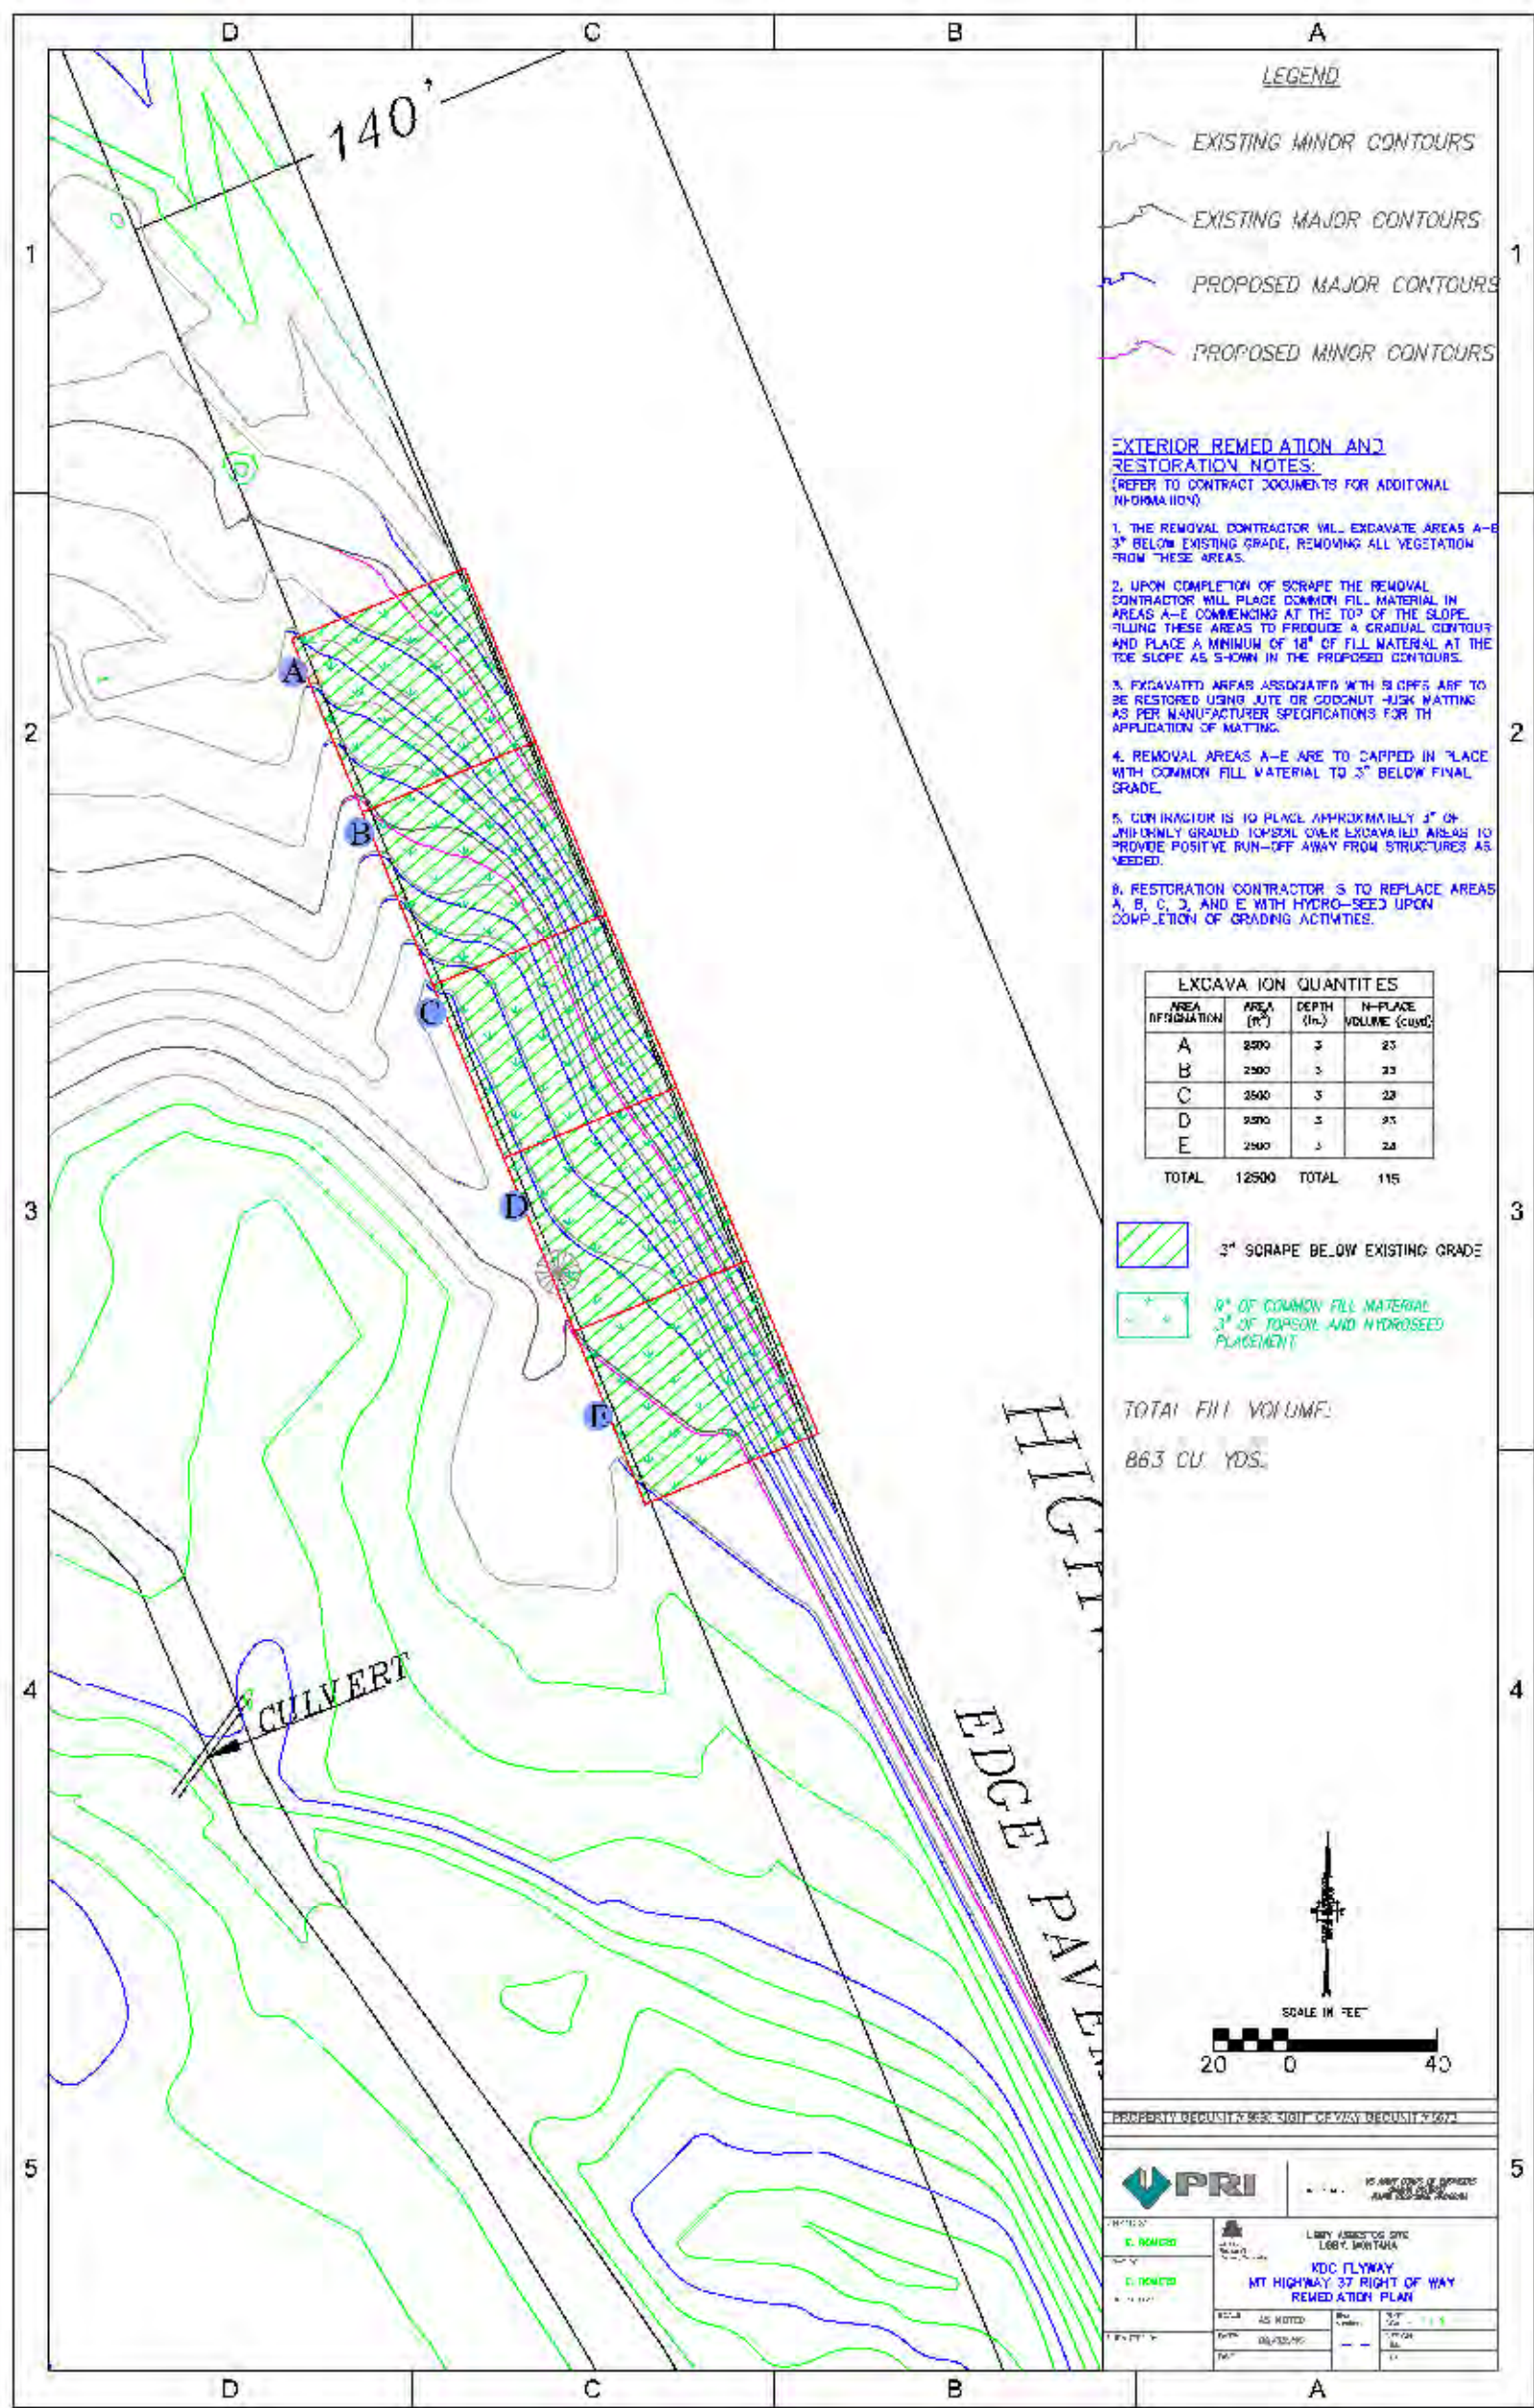
Figure 3-1
Remediation Design
KDC Flyway: MT Highway 37 Right of Way
Libby Asbestos Superfund Site
Lincoln County, Montana

The ROD required that excavation continue until source material was removed (to a maximum depth of 3 feet) and if contamination continued below 3 feet, that a visible marker layer be placed prior to backfill. Excavation in the Highway 37 ROW was limited to a depth of 6 inches due to highway structural integrity concerns, so contamination could not be removed beyond this depth. EPA determined that the marker layer was not necessary in the ROW because confirmation soil samples contained low concentrations of LA and minor amounts of visible vermiculite were observed on the floor of the excavation.

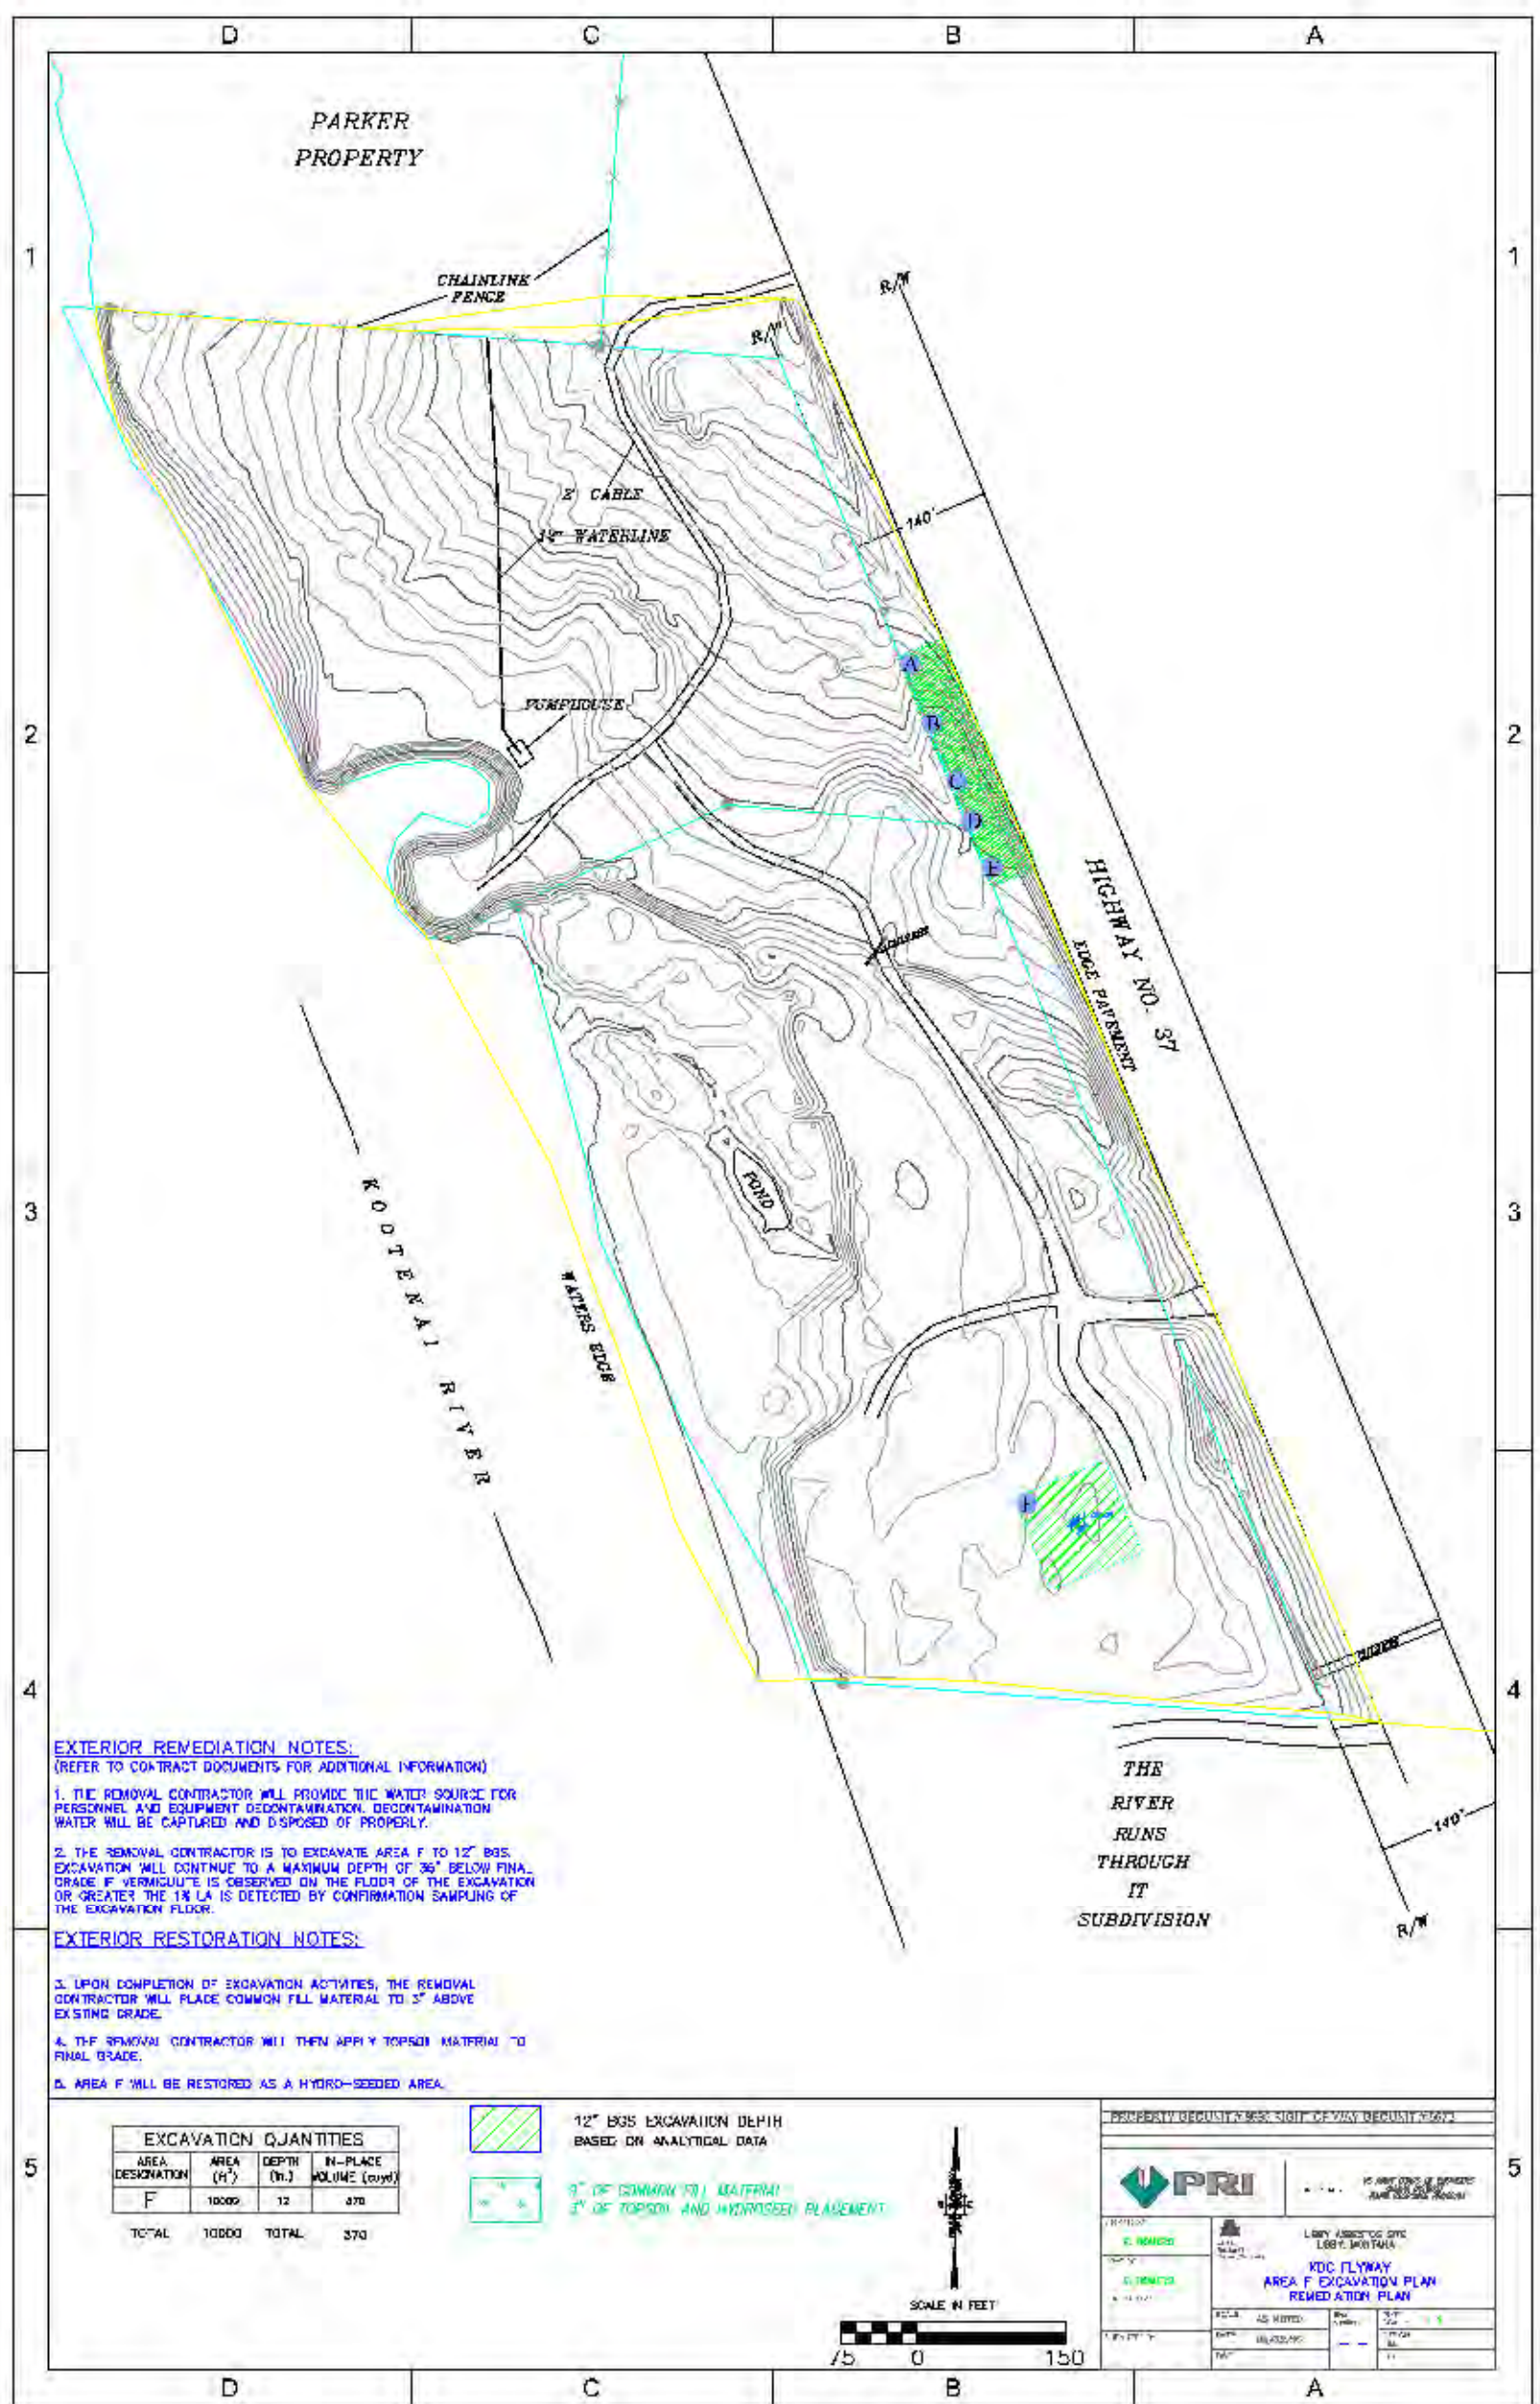
Figure 3-2
Remediation Design
KDC Flyway: Area F
Libby Asbestos Superfund Site
Lincoln County, Montana

A visible marker layer was not placed at the bottom of the excavation prior to backfill. The marker layer was not necessary in Area F because all confirmation soil samples were ND for LA and no visible vermiculite was observed at the bottom of the excavation. EPA determined that the marker layer was not necessary in Areas A

Area F was backfilled with 9 inches of common fill, placed and compacted in 3- to 6-inch lifts, followed by an additional 3 inches of topsoil. Restoration of Area F began on September 29 and was completed on October 4, 2010. It should be noted that the dates on the Property Closeout Checklists (PCCs) reflect both the ROW and Flyway excavation and restoration. The more specific dates provided in this section are taken from QARs.
